Queensbury Tunnel

Emergency infilling of No.2 Shaft

OCTOBER 2019

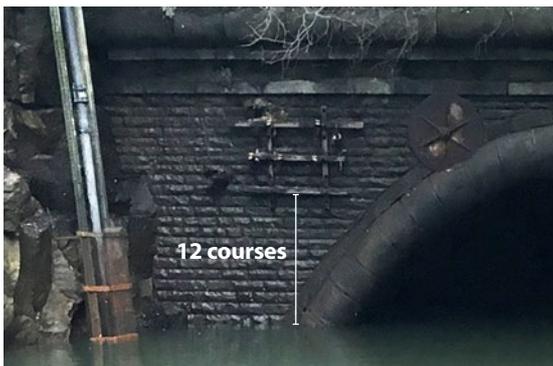
The south portal's headwall at 15:50hrs on 25 September, showing 12 courses of stonework below the timber frame.

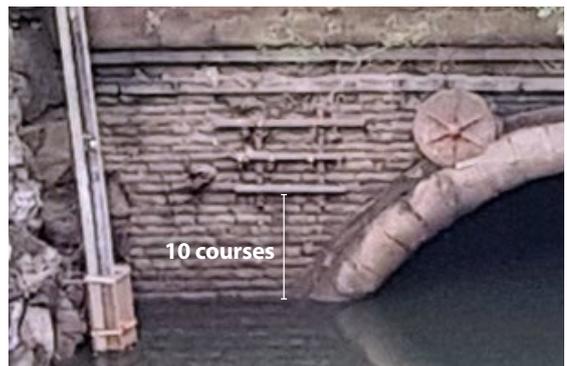
The south portal's headwall at 15:10hrs on 27 September, showing 10 courses of stonework below the timber frame.

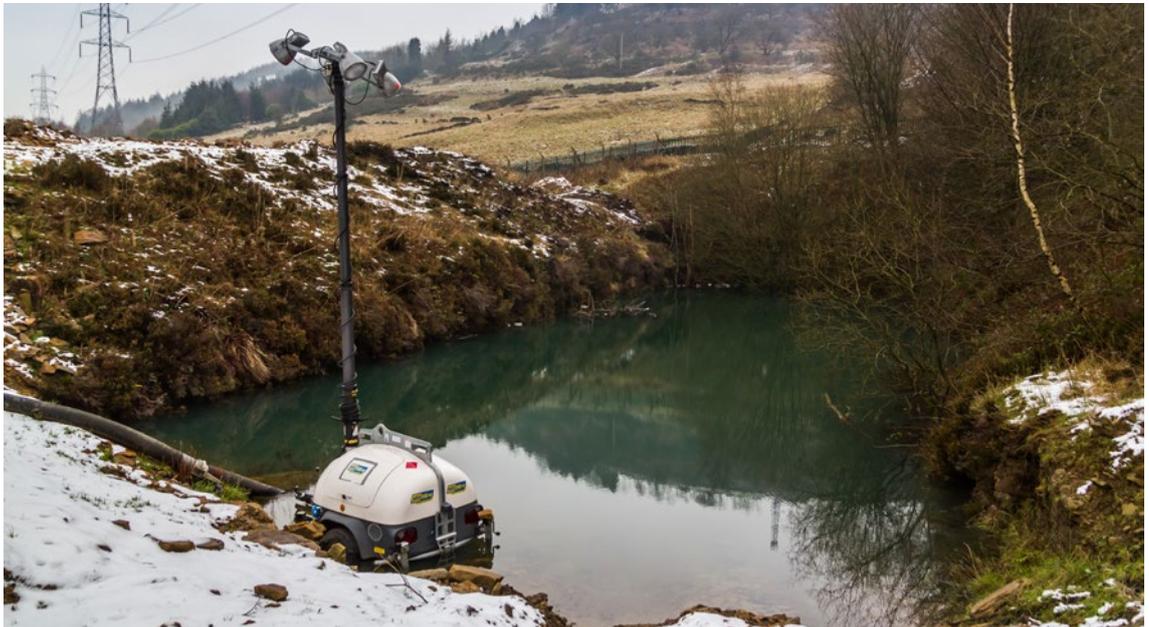
*In January 2016, flooding in the approach cutting was at the same level as 2nd October 2019.
© Forgotten Relics*

The water level recorded in the tunnel following the influx was no higher than the level it typically attained during periods of peak flooding from 2006-2012 and 2013-2016.

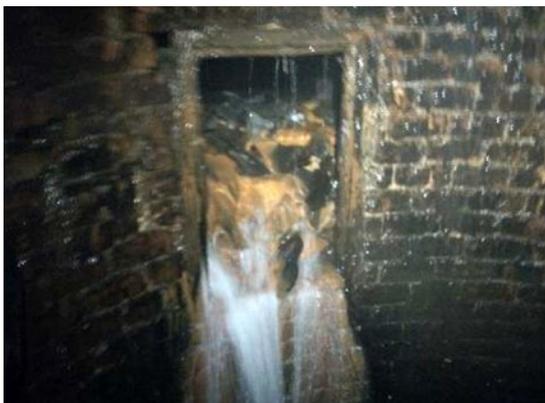
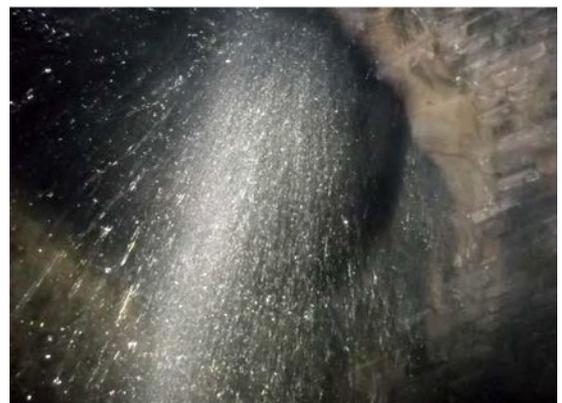
(Top) A general view of No.2 Shaft taken in March 2016.
(Above left) Approximately 19.5m from the bottom of the shaft is an adit from which a significant volume of water is discharged.
(Above right) The shaft eye.

No.2 Shaft is one of the greatest sources of water ingress into the tunnel. Around 19.5 metres (64 feet) from the bottom is an adit from which floodwater is thought to discharge from adjacent fireclay workings. Infilling the shaft in the manner proposed by Highways England raises future issues around drainage and flood risk, and concerns have already been raised by Bradford Council.

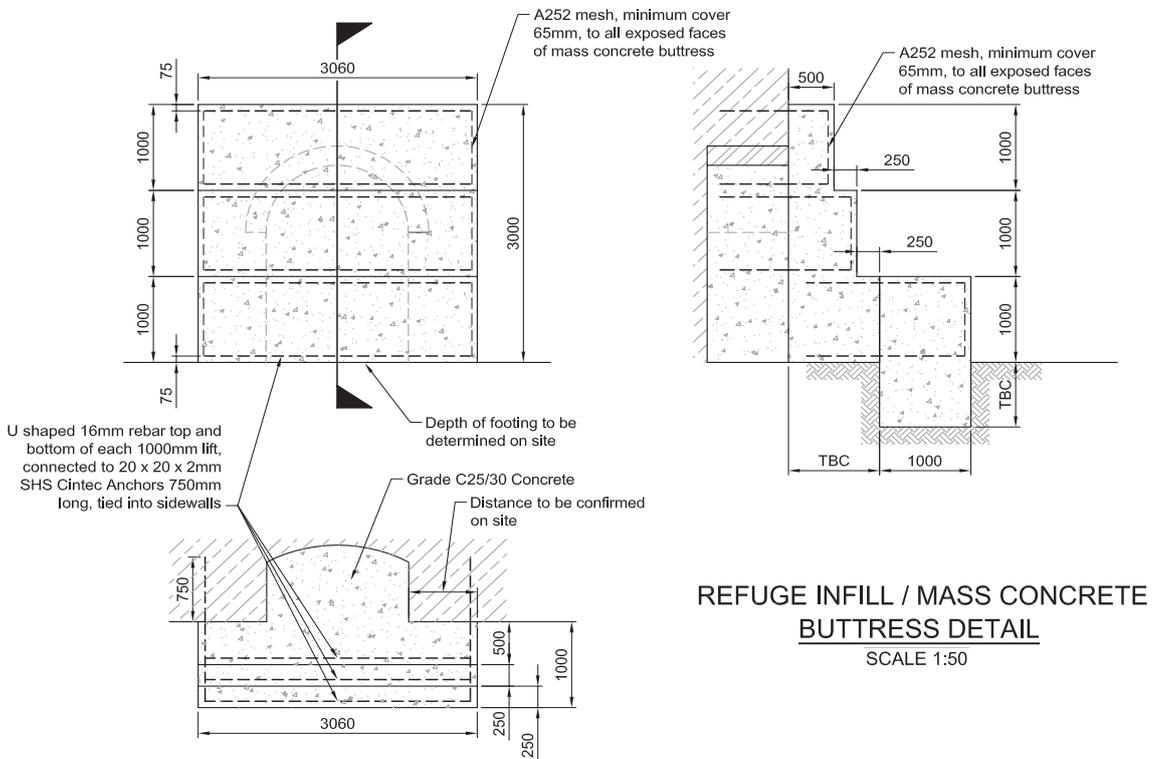
During an inspection in 2012, it was observed that a trackworker refuge 5 metres south of No.2 Shaft had started to fail. Jacobs, Highways England’s consulting engineers, developed a repair to resist any further movement, comprising a mass concrete buttress. However the work was never undertaken.

A mass concrete buttress designed by Jacobs, Highways England’s consulting engineers, in 2012 as proposed remediation at the failing refuge. The work was never undertaken.

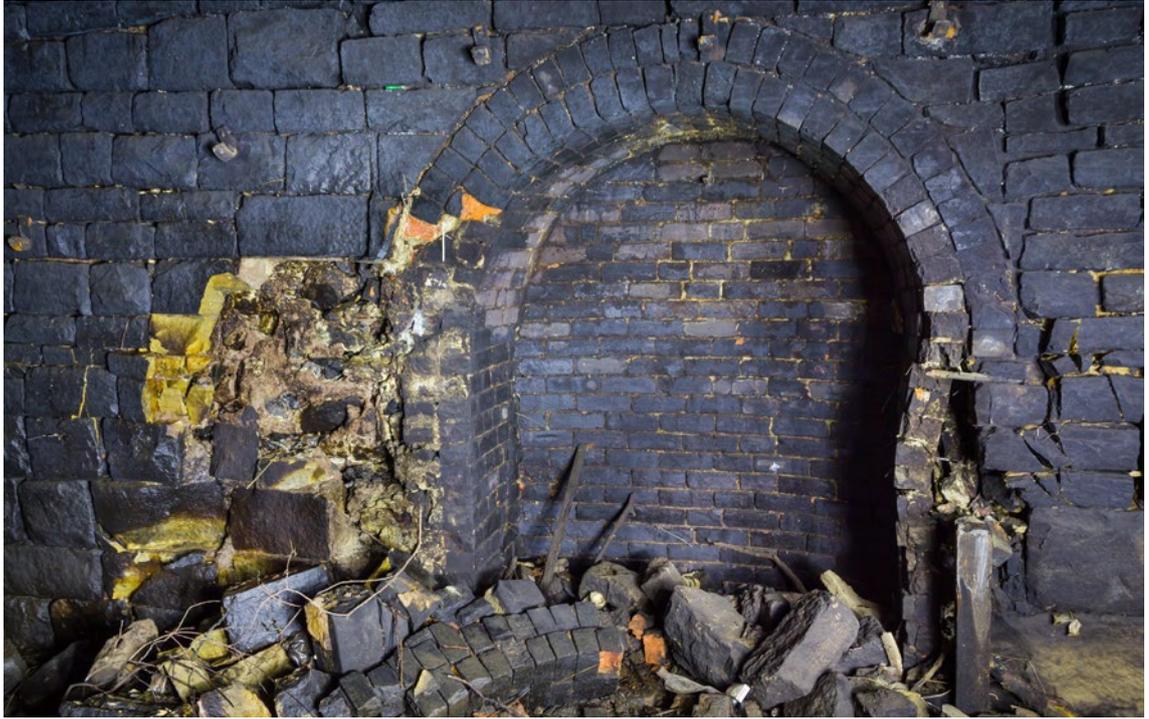
Some of the adjacent masonry facework has since collapsed and a bulge has formed on the north side of the refuge, extending diagonally upwards to a height of approximately 2 metres. However there is currently nothing to suggest that this is affecting the stability of the shaft. There are no other signs of distress and the tunnel’s profile has not significantly changed since construction, as evidenced by the Geoterra 3D point cloud laser scan undertaken in August 2018 as part of a broader study by AECOM into the tunnel’s condition.

View of the failing refuge 5m south of No.2 Shaft.
© Forgotten Relics

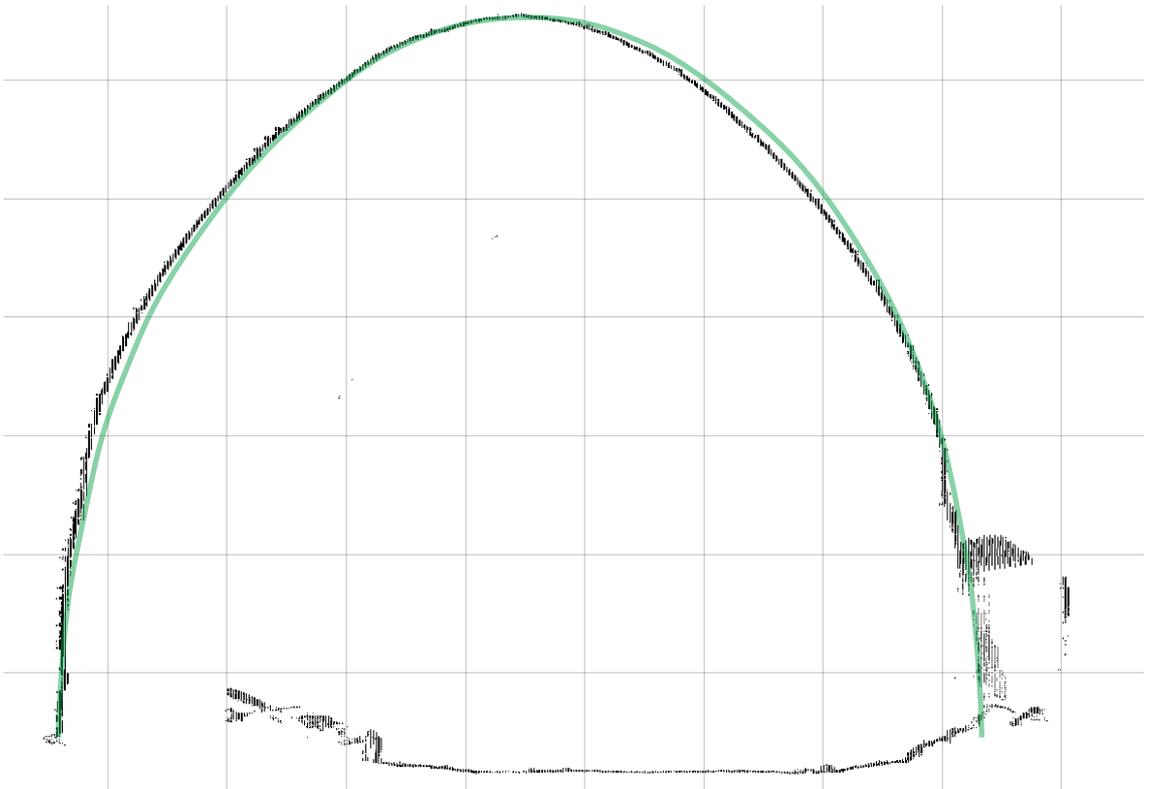
A laser scan of the tunnel profile (looking south) immediately north of the refuge, suggesting a deflection at the haunches of ~150mm. The original/unchanged profile is overlaid in green.
© 2018 Geoterra/AECOM Infrastructure & Environment UK Limited

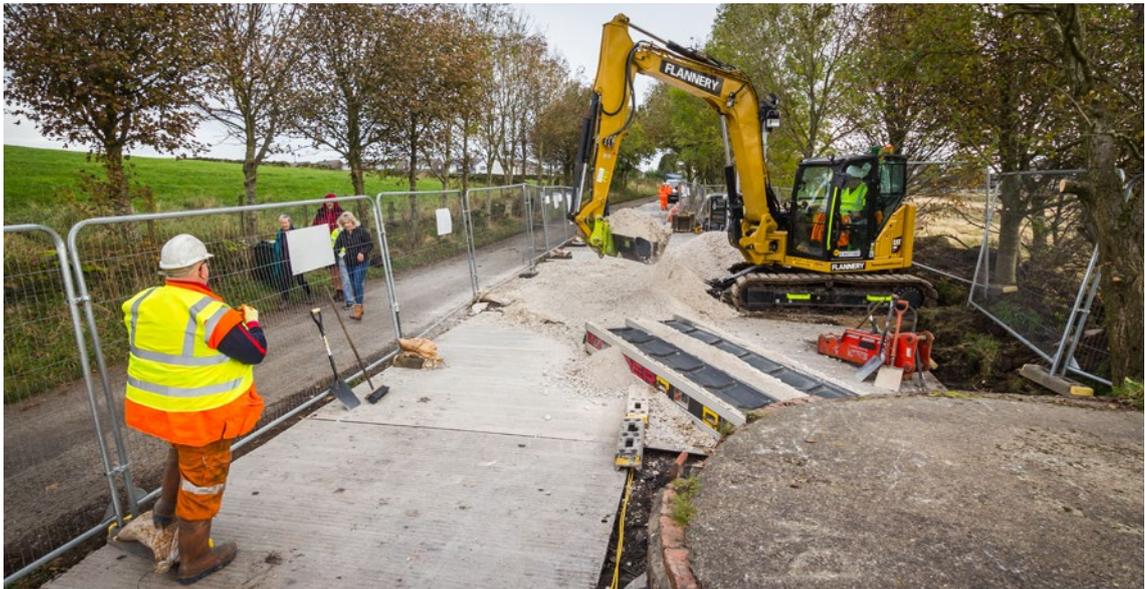
Where there are doubts about the stability of a shaft - as is clearly the case here through the use of emergency powers - the handbook states that a potential collapse zone should be determined and clearly delineated on site by an appropriate means, such as a fence. No-one should enter the collapse zone unless they are wearing a safety harness anchored at least 5 metres outside it. In all cases when filling from the surface, the conveyor carrying material to the shaft should be loaded at a point at least 10 metres outside the collapse zone. The absence of such safeguards at No.2 Shaft (see photo below) add to doubts as to whether the attendant risks constitute a genuine emergency.
