Queensbury Tunnel

Emergency infilling of No.2 Shaft

OCTOBER 2019

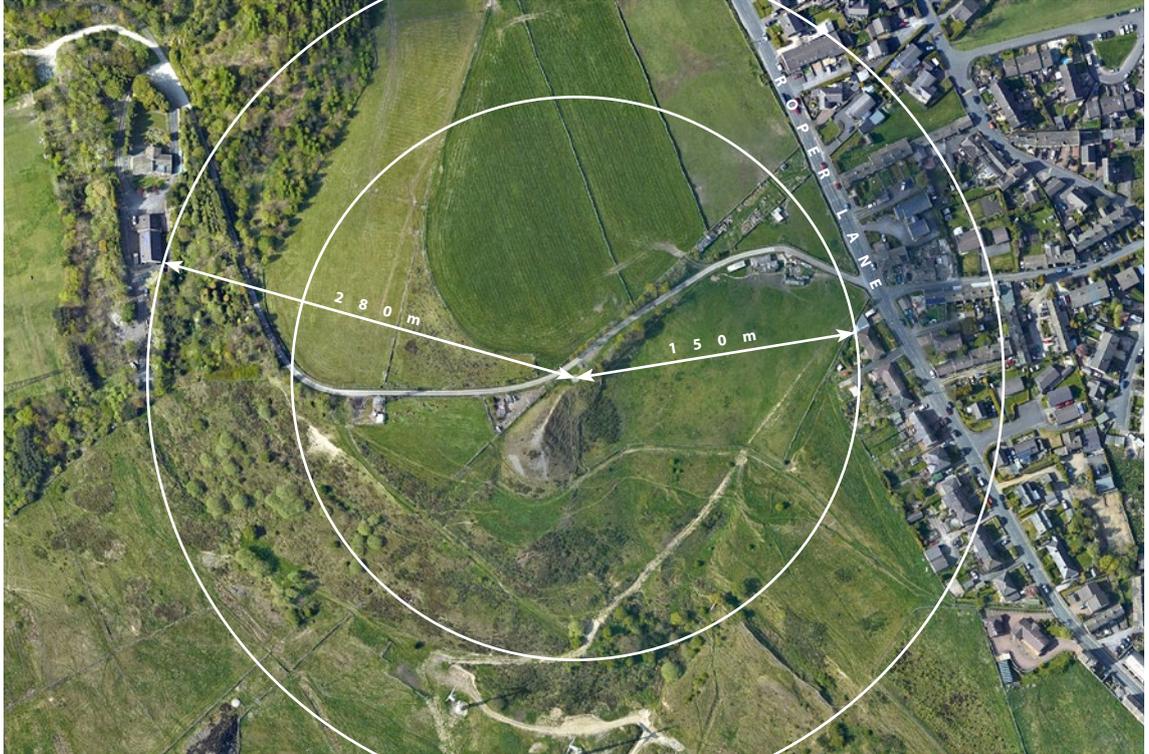
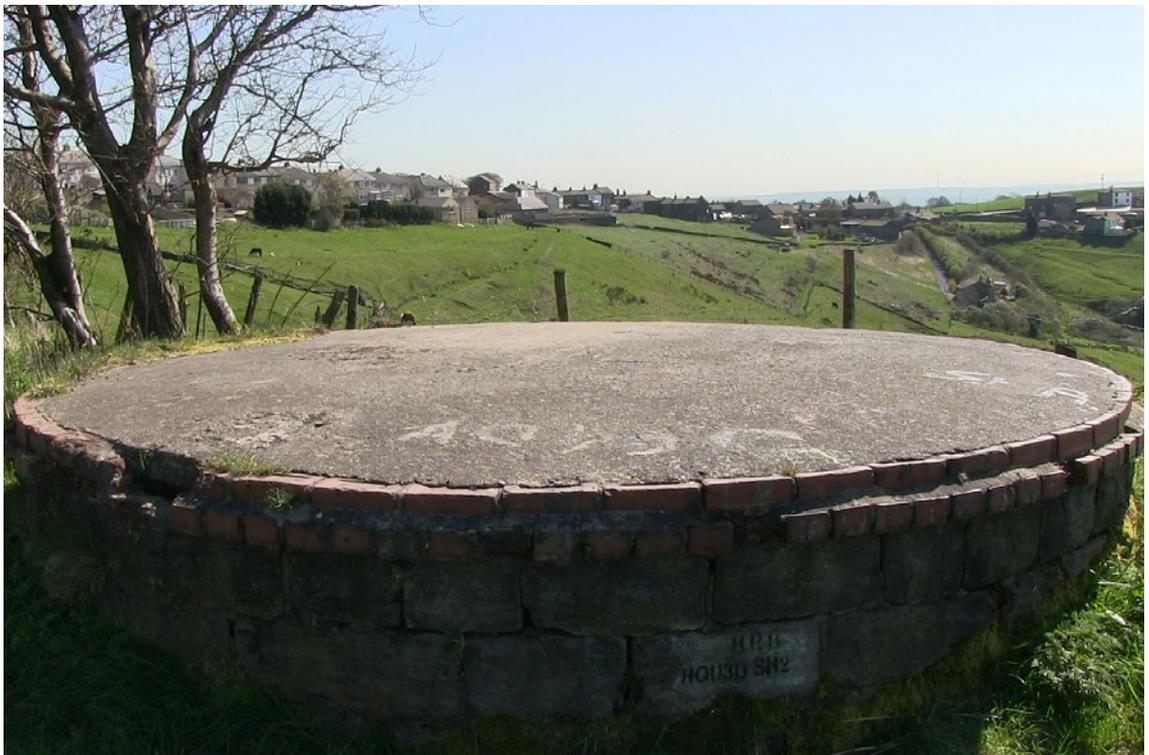
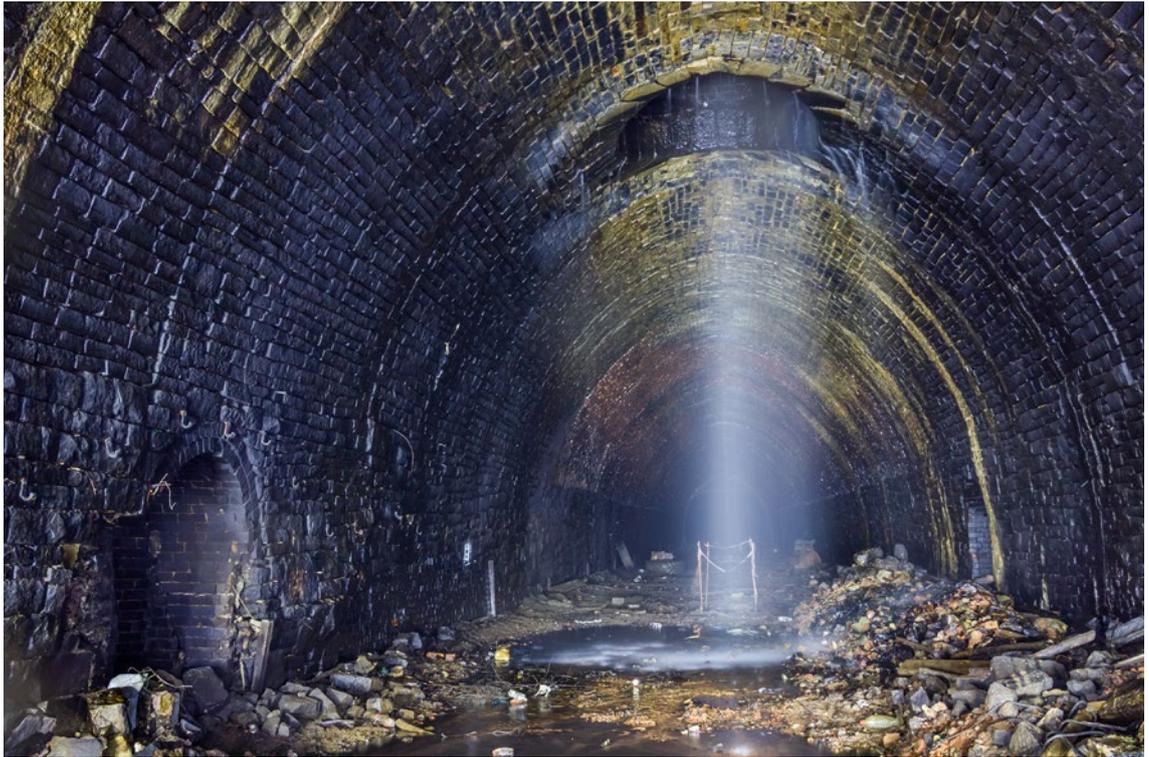
No.2 Shaft is 99 metres (324 feet) deep and 2.75 metres (9 feet) in diameter. It is located alongside a farm access road which joins Roper Lane 180 metres from the shaft. The nearest property to the east is 150 metres away; to the west there is a farm building 230 metres away.

The shaft lining was constructed in two sections, with the upper part reaching a depth of 39 metres (128 feet) from the surface where it is supported on a rock ledge. Below is a 4-metre (12 feet) unlined section of competent rock. The lower part of the lining is 56 metres (184 feet) deep and is likely to weigh in the region of 218 tons.
