Queensbury Tunnel

Cost Comparisons

F E B R U A R Y 2 0 1 7

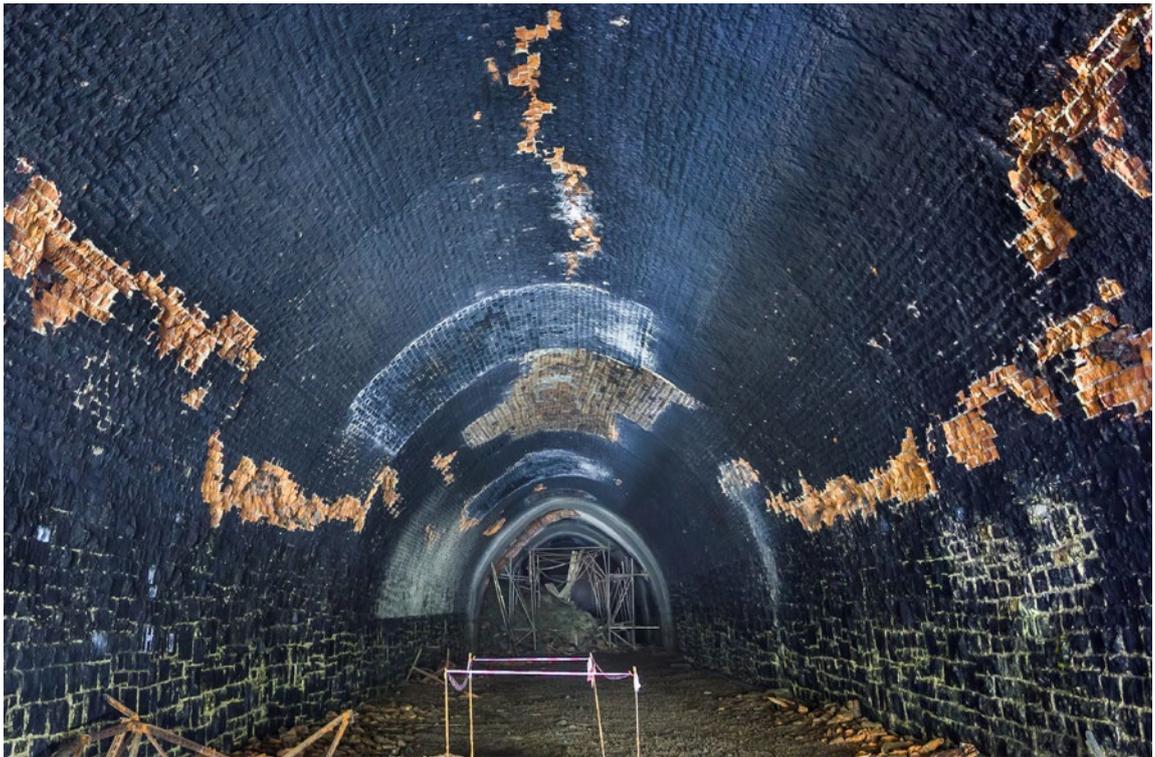
It is clear that the condition of Queensbury Tunnel deteriorated in the seven years between Jacobs' two reports. Notably, partial collapses occurred in 2013 and 2014, and severe defects were identified at four other locations. Deep spalling and panels of missing brickwork are indicators that more failures are likely in the future (see photo above).

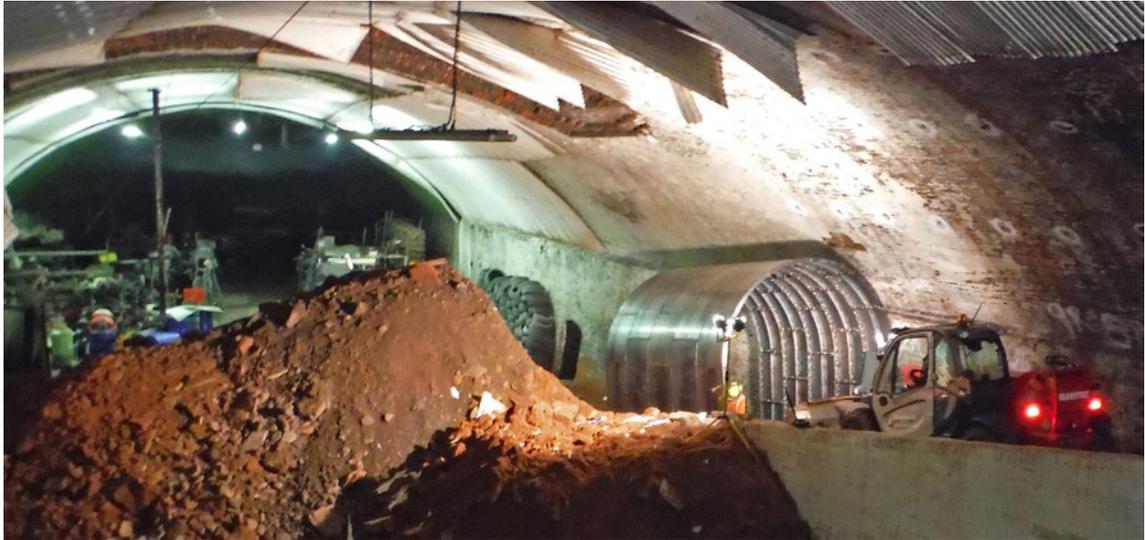
Using a design developed during its remediation of a large collapse in Liverpool's Dingle Tunnel (see photo above), SES Group was able to cost repair of the two collapses in Queensbury Tunnel at around £275,000. This figure aligns closely with that of the Dingle project when adjustments are made for the quantities involved. Beyond this, an engineering consultant and two contractors have separately estimated that a secondary spray concrete lining could be installed through the entire length of Queensbury Tunnel (2,287 metres) for £5-10 million, depending on its thickness (150-300mm).

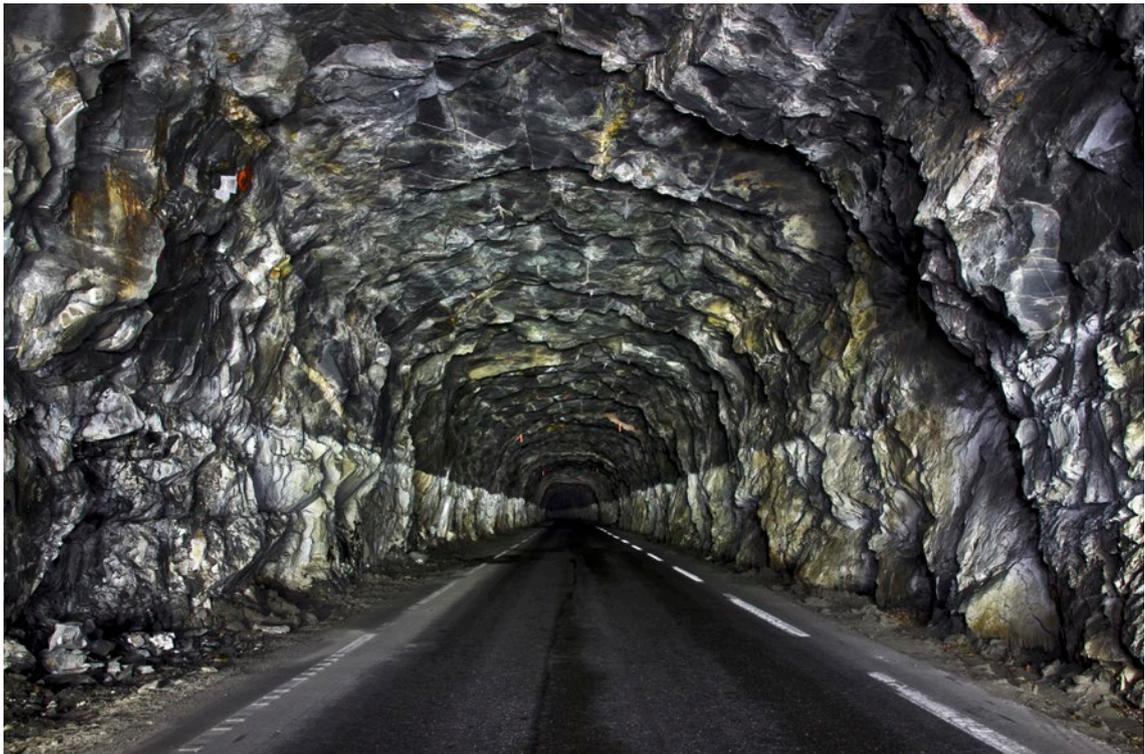
One of the many 'drill and blast' road tunnels in Norway where the engineering approach and regulatory culture results in considerably lower construction costs than in the UK (see Section 3.4).

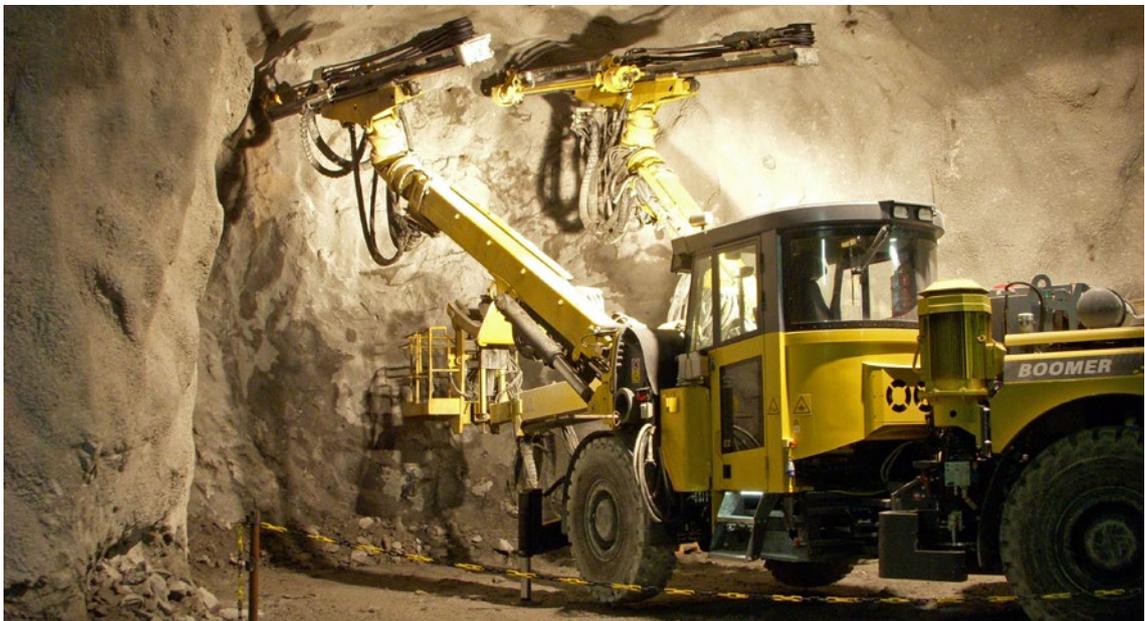
A multi-boom machine drilling holes in a tunnel's working face.
